Comparison of Concrete Masonry Unit(CMU) from Haiti VS United States

Gael Lamothe, Dr. Andre Filiatrault

Department of Civil, Structural, and Environmental Engineering
University at Buffalo (SUNY)

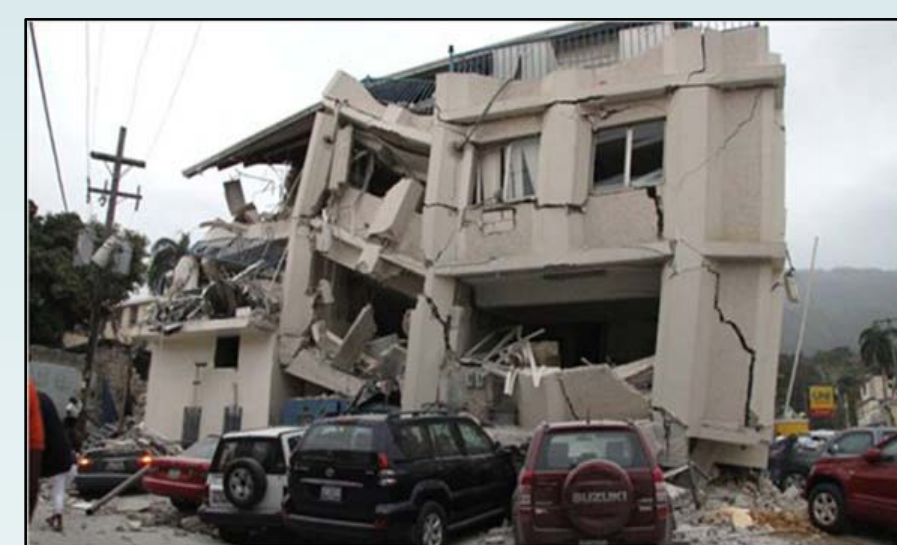
(c) Residential Building

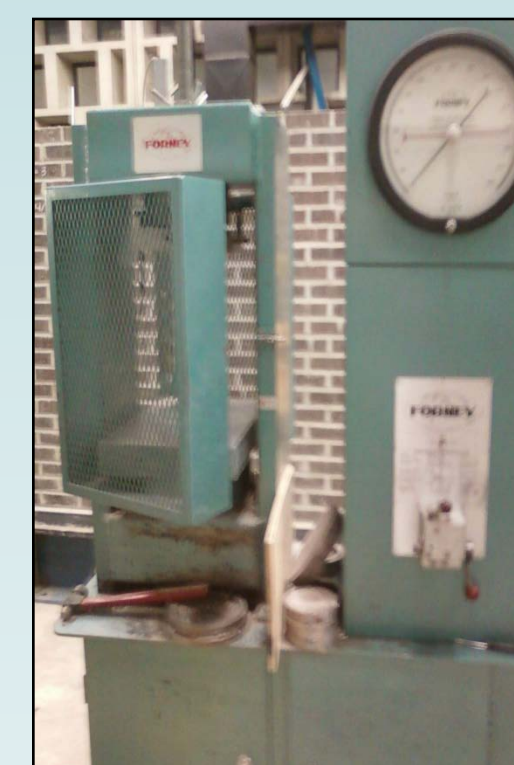
(a) Unloaded machine

- Step 1 • Obtained blocks from a random construction site in the United States
- Step 2 • Acquired blocks from a manufacturing company at Home depot in United States
- Step 3 • Acquired common construction blocks from Haiti
- Step 4 • Predicted the data according to the current hypothesis
- Step 5 • Used Forney Concrete Testing Machines according to ASTM C 1716 standard to test the compressive strength of the blocks

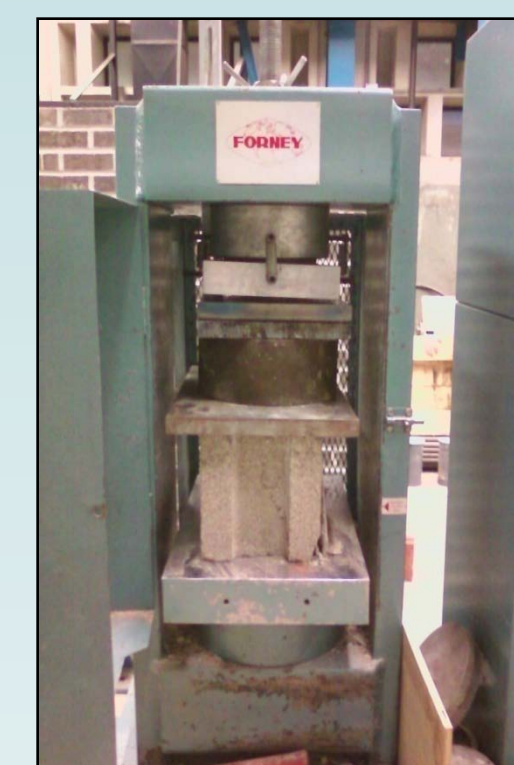
(b) Loaded machine

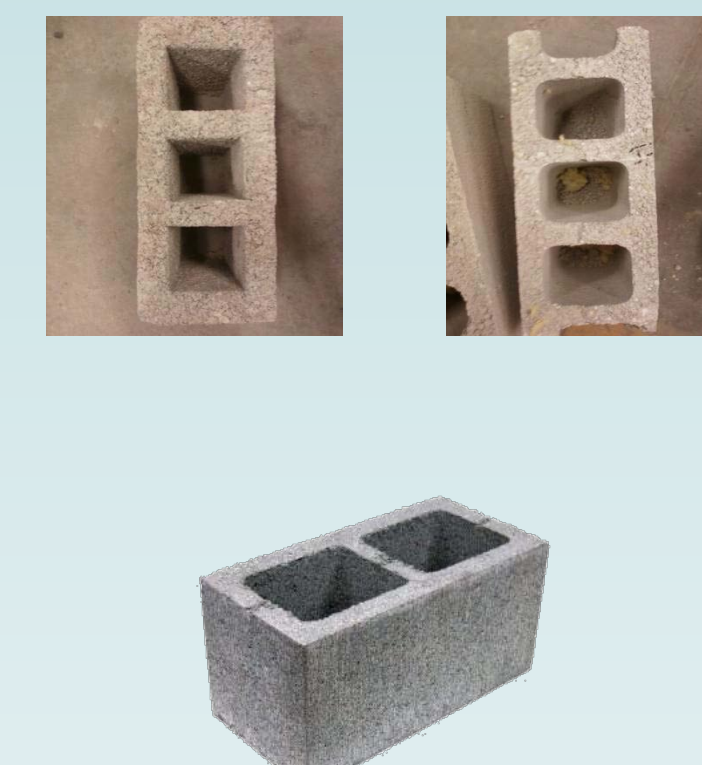
(c) CMU sample

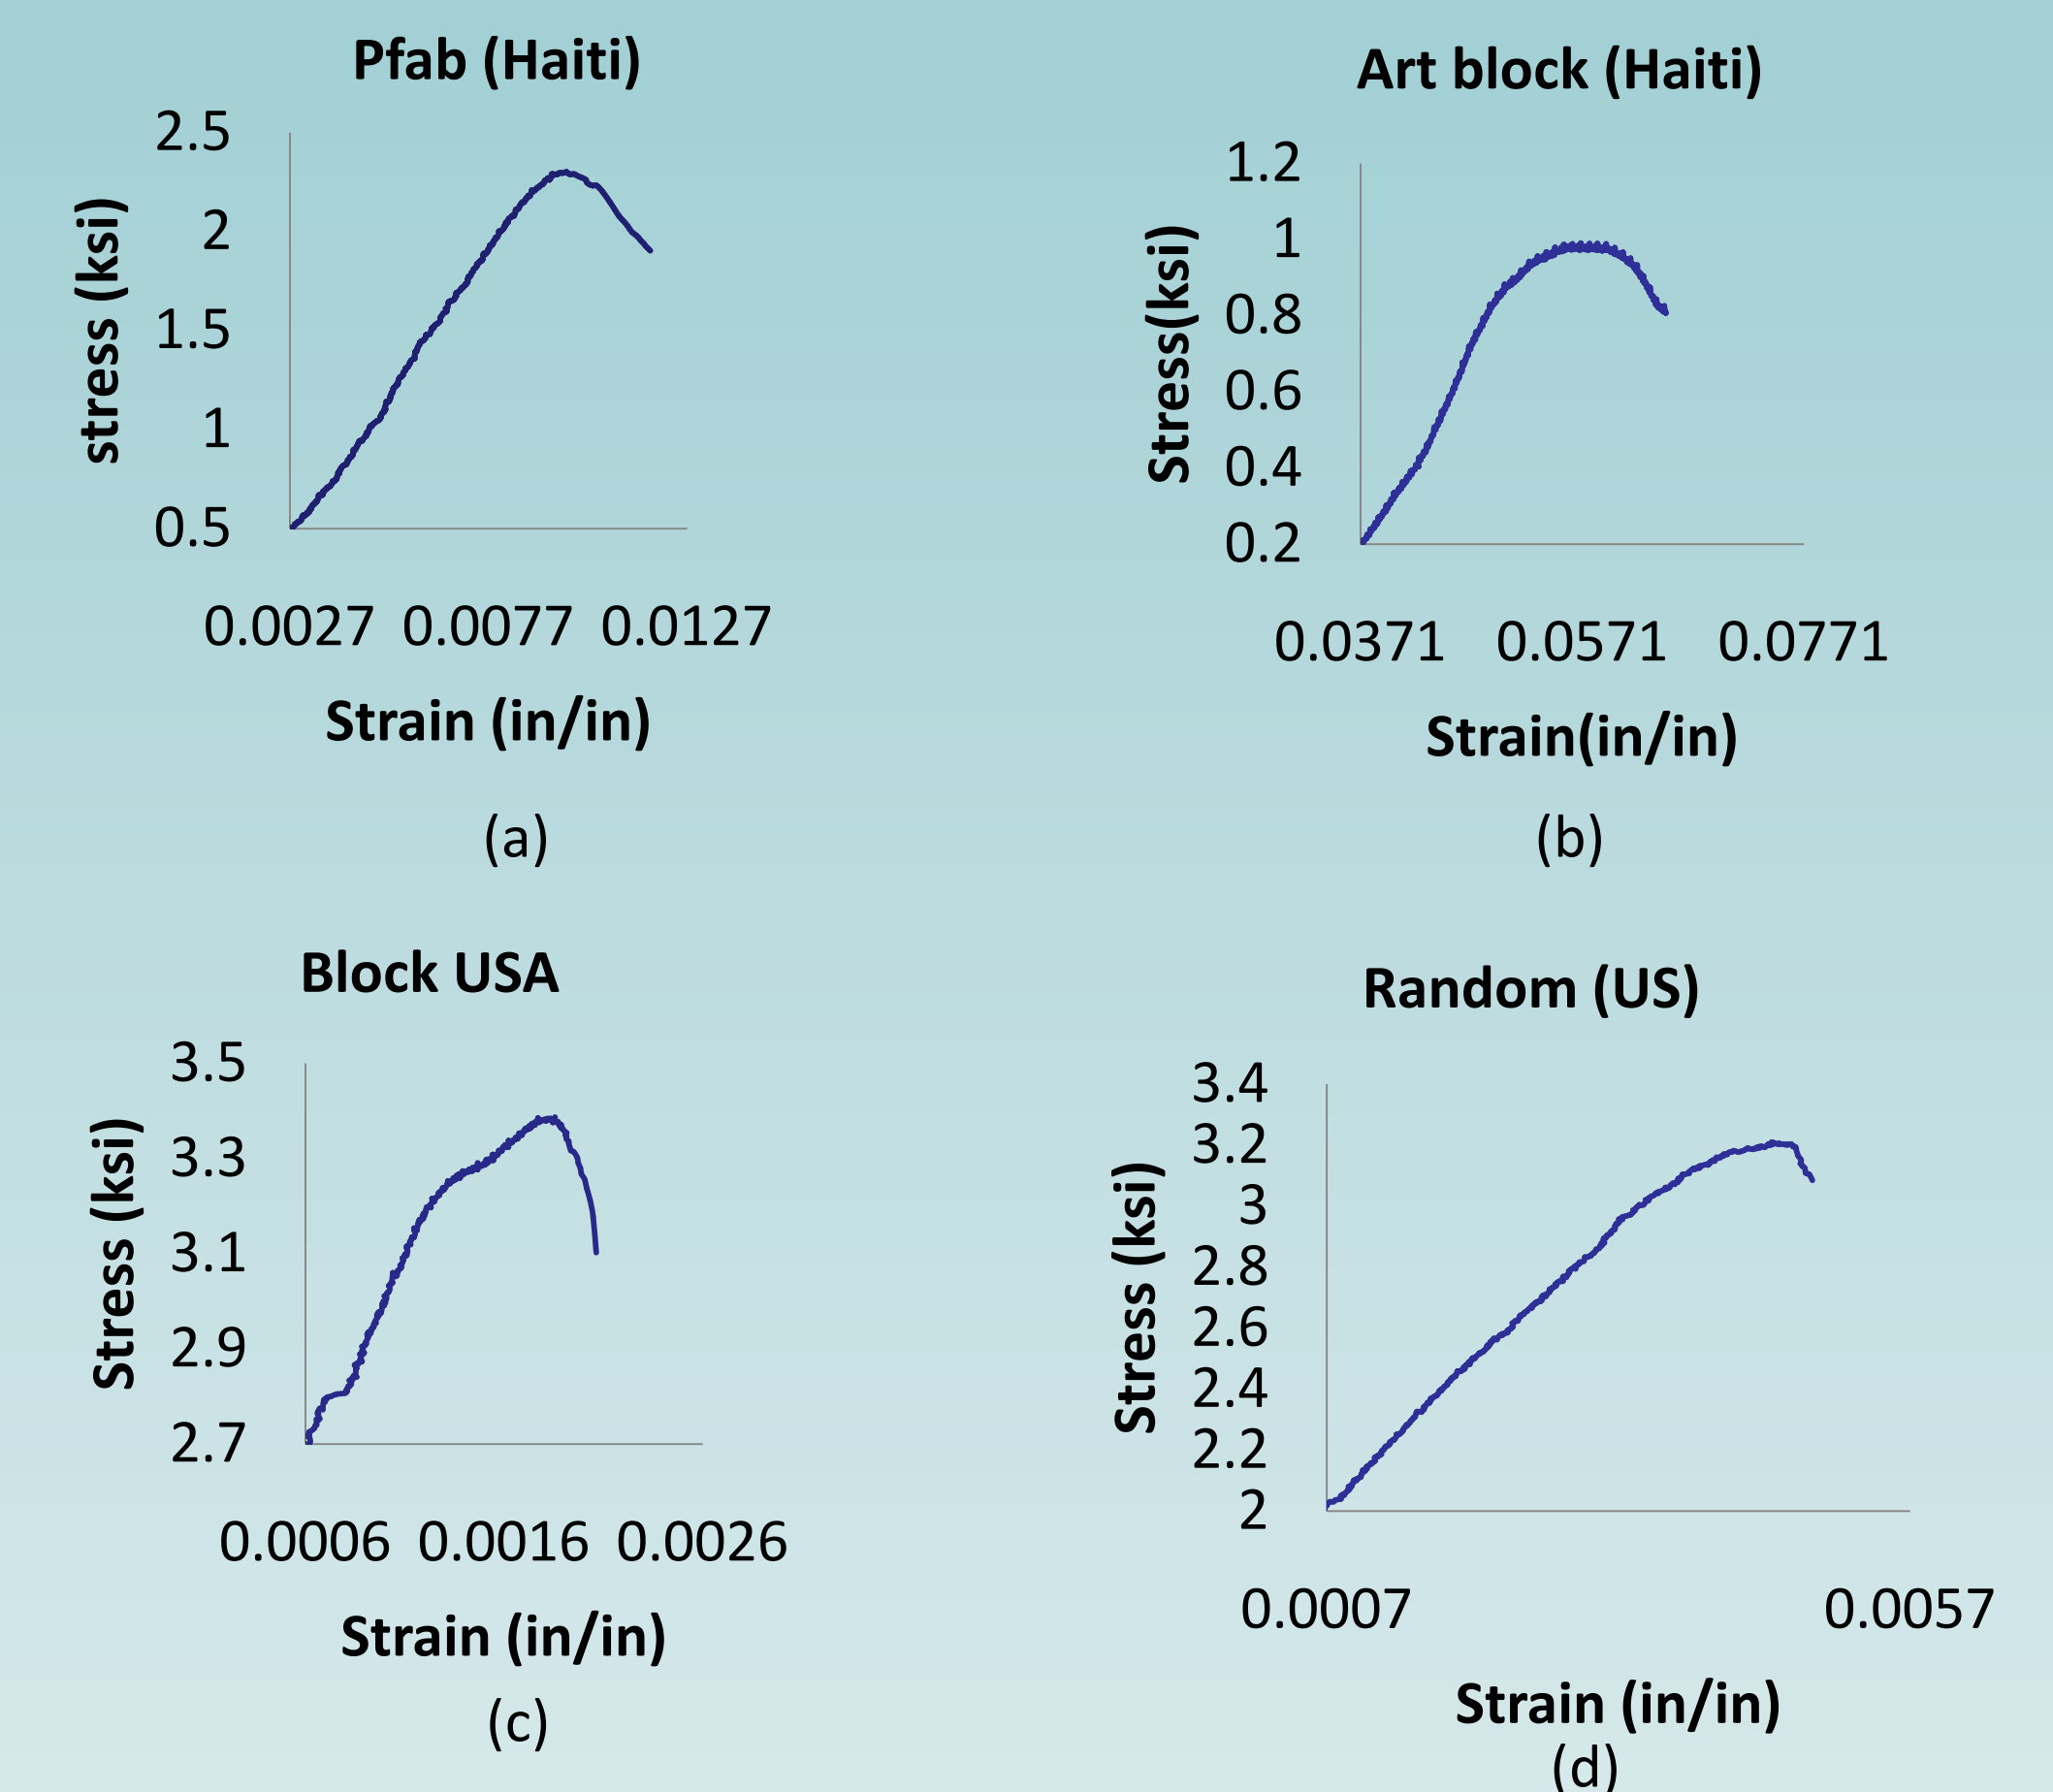
Figure 1: The block from Pfab has the maximum compressive stress around 2.4 ksi and the art block around 0.9 ksi.

- a) Stress-strain curve for a Pfab block from Haiti
 - b) Stress-strain curve for an art block from Haiti
- The two blocks from the US break around the same point with a maximum compressive around 3.3 ksi.
- c) Stress-strain curve for a block U.S.A block
 - d) Stress-strain curve for a random block from the U.S

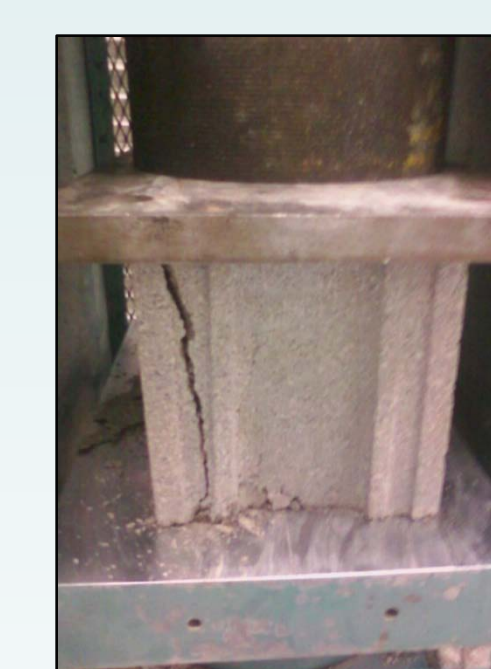
(a) Failed sample from the US

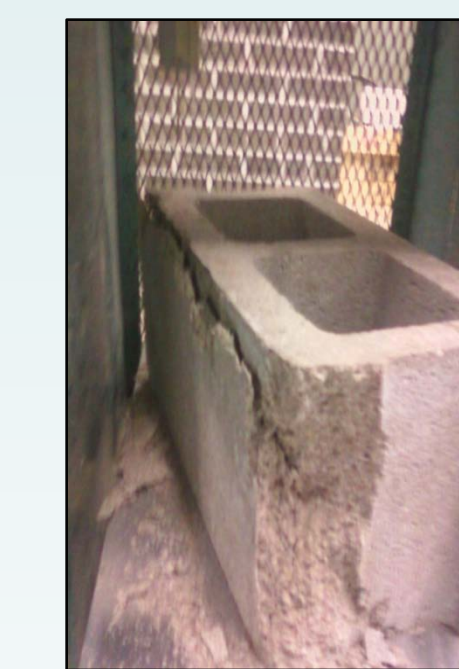
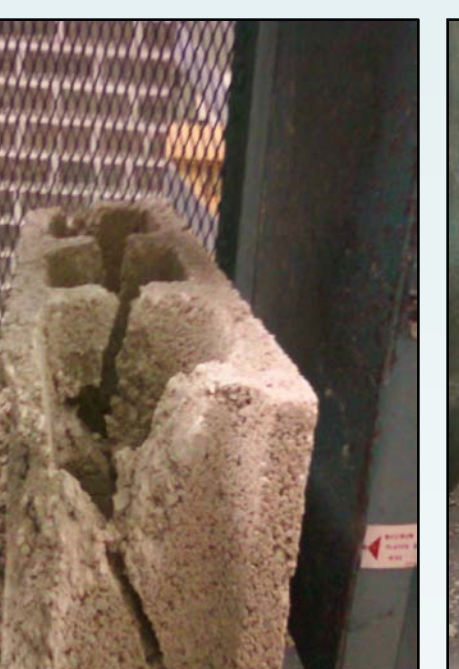
(b) Failed sample from Haiti

- CMUs in Haiti are made out of poor quality materials
- Pfab only reliable brand of CMUs in Haiti but there is room for improvement
- Recommendations:
 - Test the CMUs for compressive strength before using them
 - Upgrade materials quality
