# Design of a Low-Cost Sky Imager for Solar Forecasting

**Brian Kiel, R. Jamie Asbach**

**Advisor: Dr. Tarunraj Singh, Mechanical and Aerospace Engineering**

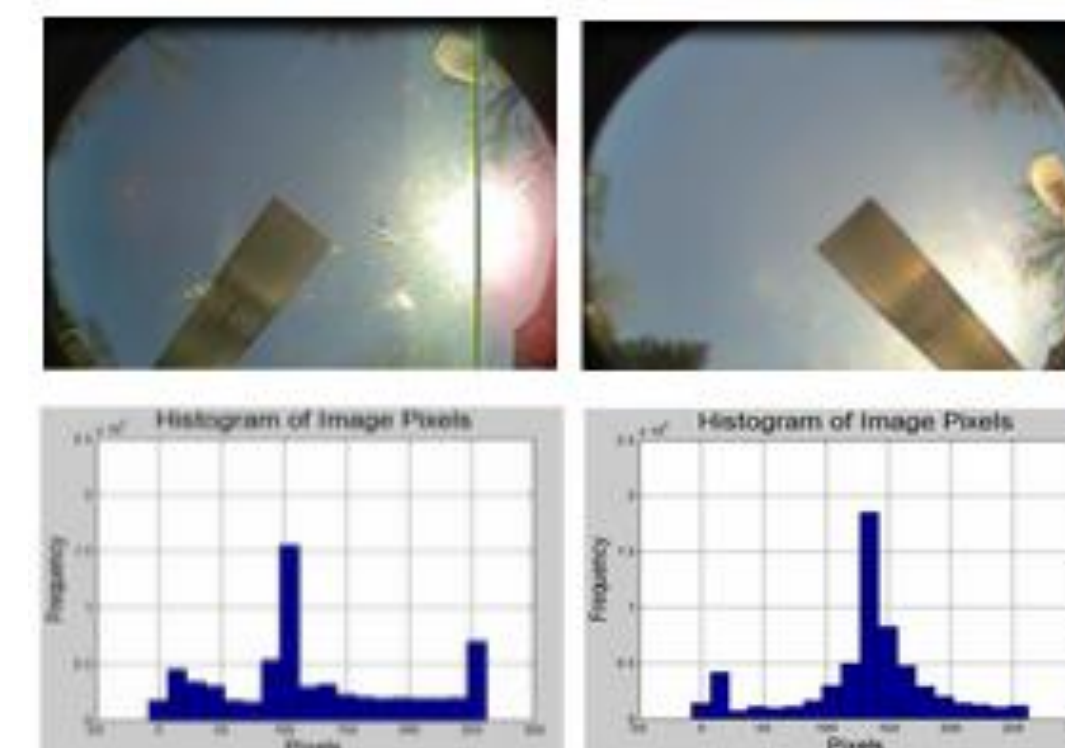
### Sun Blocking Results - Success

As seen in the image to the right, the arm worked very well in improving the image. On a scale from 0-255, less pixels were maxing out the camera (250-255 range), which protects the camera from damage. Also by visual inspection, the covered image has less solar distortion.
